WATER DAMAGE ASSESSMENT

**Crisafulli Elementary School
13 Robinson Road
Westford, Massachusetts**

Prepared by:
Massachusetts Department of Public Health
Bureau of Environmental Health
Indoor Air Quality Program
October 2019

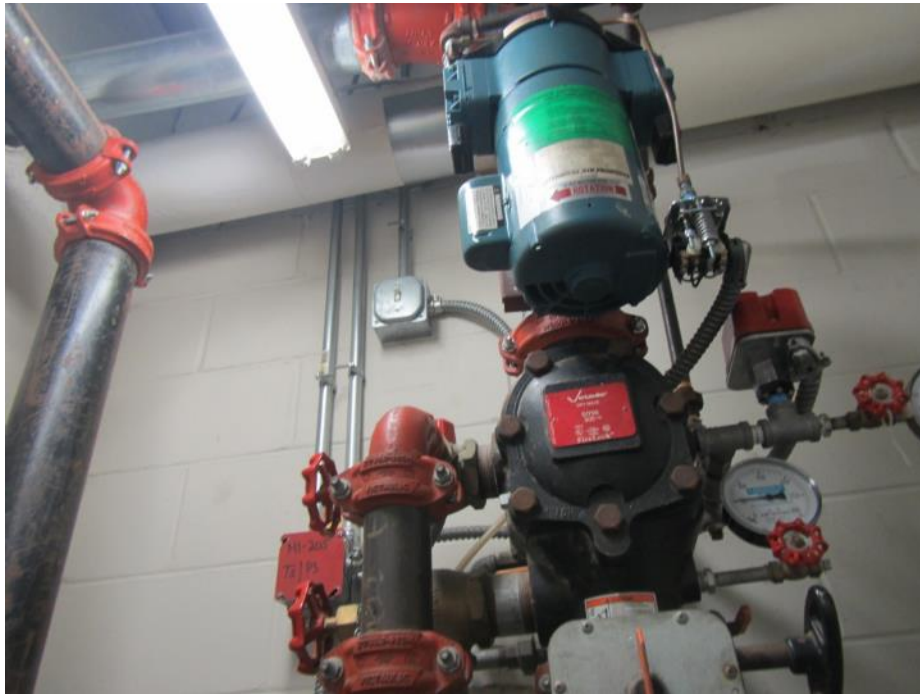
Picture 1

CES Facilities staff reported that a sprinkler system line in janitor closet #3 began leaking while the building was occupied (Picture 1). Due to the water being stagnant in the sprinkler lines, a foul odor was detected. Facilities staff immediately began to extract the water from the area and began drying activities within the first hour of the leak being discovered. In addition to drying activities, Facilities staff removed and discarded any porous material that was in contact with the leaking water.

Sprinkler system/lines in Janitor closet #3 where leak occurred

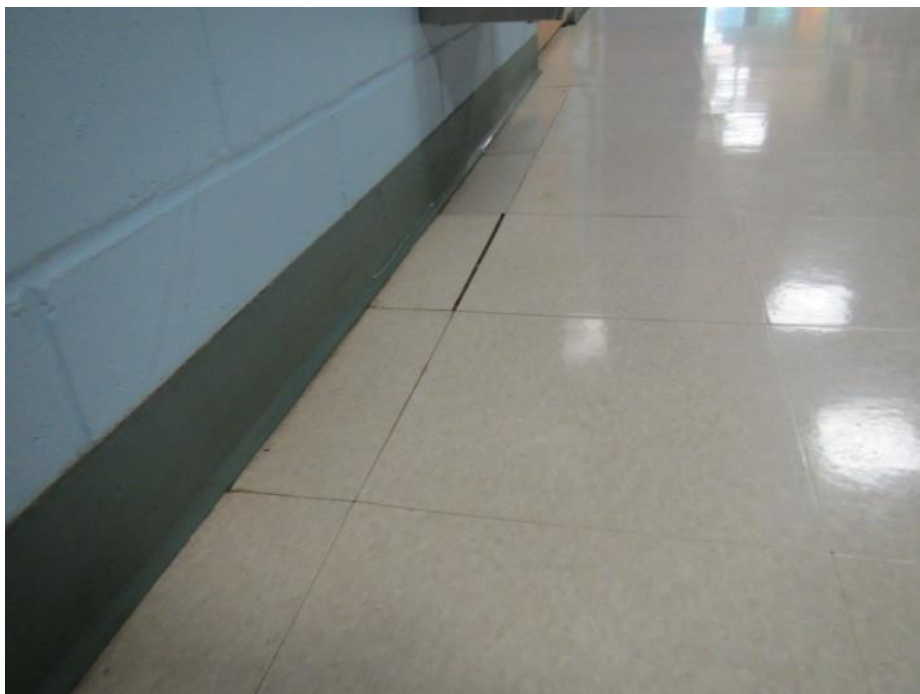
Picture 2

BEH/IAQ staff noted that some vinyl tiles in the hall outside the janitor's closet were slightly buckled (Picture 2). This condition likely resulted from the water re-activating the floor tile adhesive which then loosened the tiles. Facilities staff reported that the tiles will be removed and replaced due to the possible tripping hazard.

Buckled floor tiles in hallway outside janitor closet

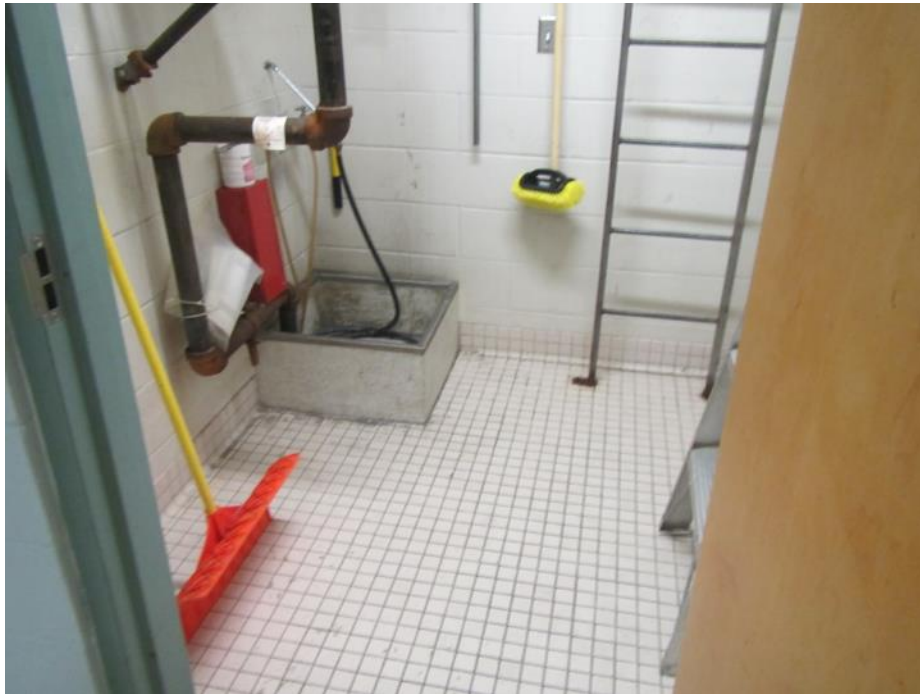
Picture 3

All building materials, in and outside the janitor closet where the leak originated, are nonporous materials (Picture 3) that are not susceptible to microbial colonization (e.g., concrete block, floor tiles). These walls and floors were cleaned and disinfected according to Facilities staff. However some occupants reported that the water flowed into an adjoining room (R3) and near the vinyl coving of a wall built with gypsum wallboard (GW). GW is considered a porous

Nonporous tile and concrete in Janitor closet #3
